# A COMPARISON OF CADASTRE IN SLOVAKIA AND POLAND

# DAM INCIDENTS AND FAILURES – CASES IN THE CZECH REPUBLIC

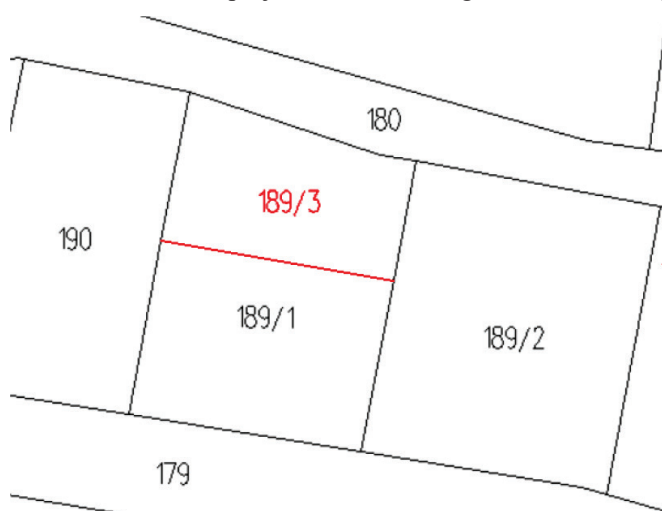
Fig. 2 Numbering of plots after 189/1 division in Slovakia. Source: authors' study

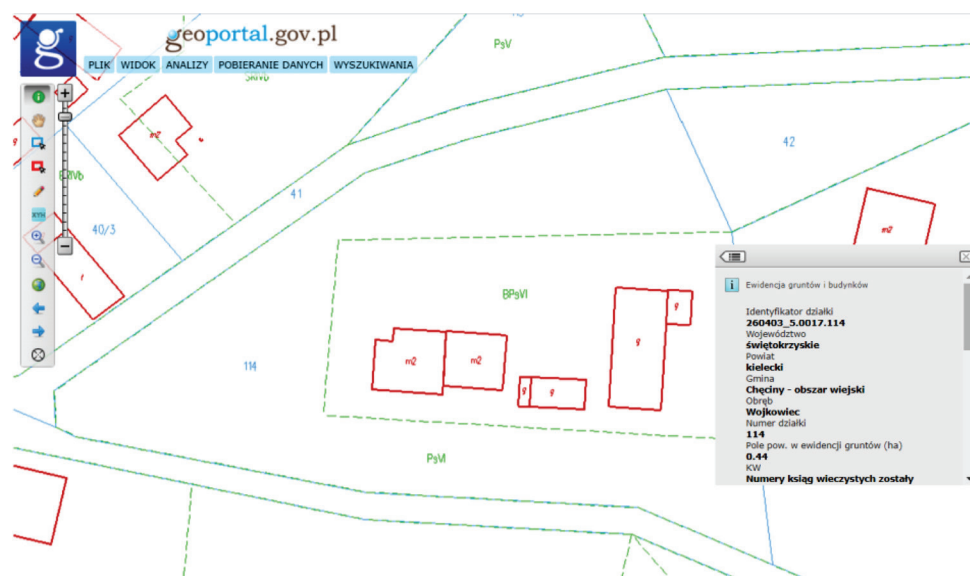
Fig. 6 Fragment of the Polish geoportal. Source: <https://mapy.geoportal.gov.pl/>

The main difference between the two is due to the nature of the cadastral systems in Poland and Slovakia. Slovakia has a full-fledged real estate cadastre that combines cadastral information, a cadastral map, and a register of rights to land, buildings and premises. In Poland, on the other hand, two databases are used for the cadastre, i.e., land and building records that provide descriptive and graphic information about land, buildings and premises, and land and mortgage registers containing information on rights to land, buildings and premises. These registers are kept by two separate institutions. There is also a greater range of entities entered into the system with rights to real estate. There is also a difference in the content of the cadastral documentation, which in Slovakia is more extensive in relation to the content of the legal data.

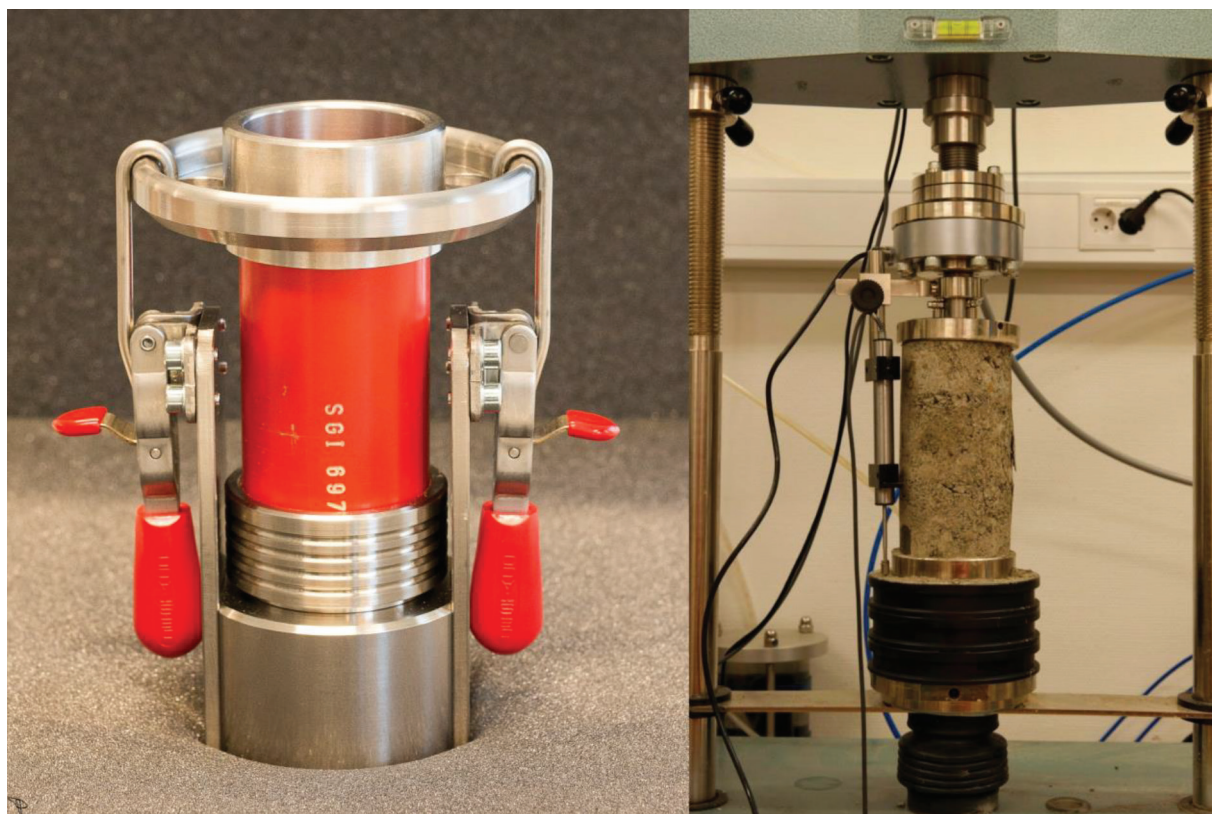
**Fig. 1** Left: Photo showing packaging equipment for packing specimens with a height of 100 mm. Right: UCS testing apparatus showing a specimen after the UCS test. Photo source: Per Lindh

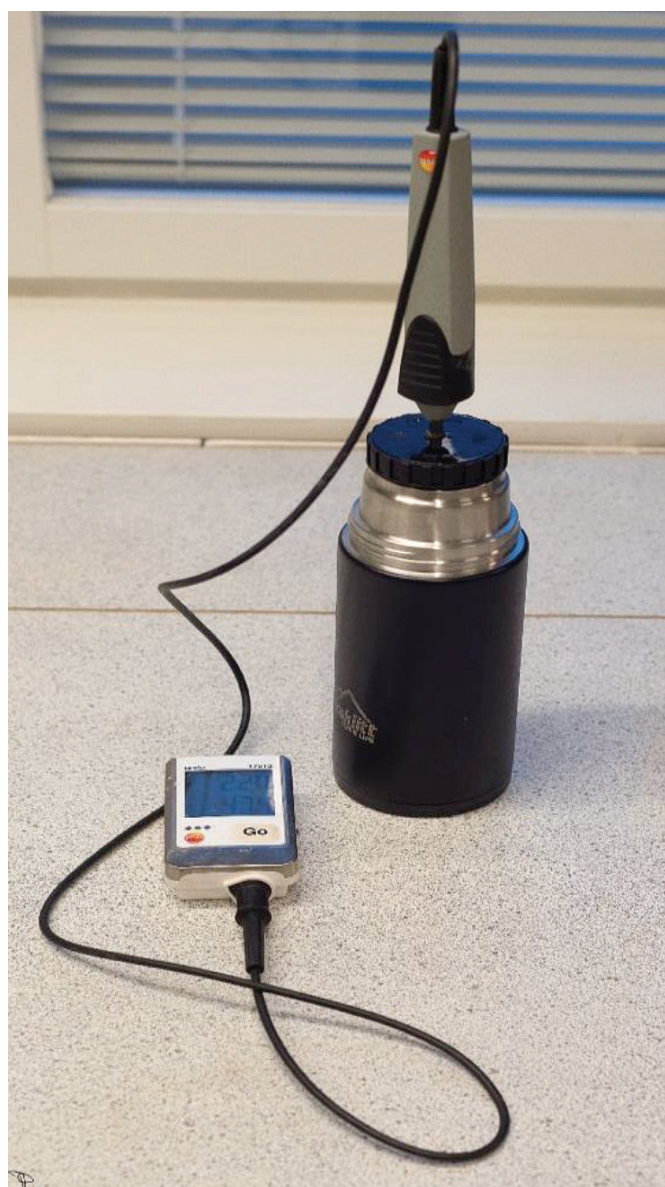
**Fig. 4** Photo showing a simplified calorimeter consisting of a thermos and a temperature logger. Photo source: Per Lindh

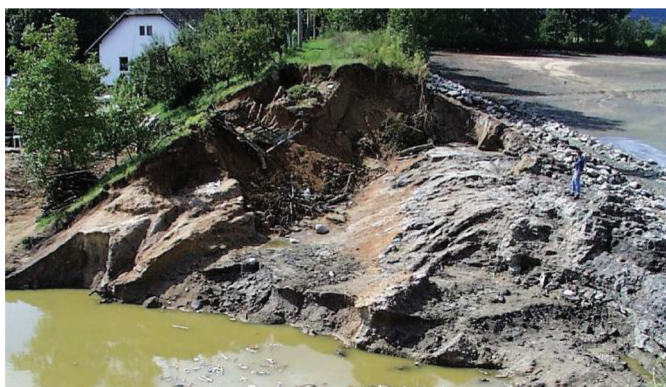
Fig. 3 The breached Metelský Dam (photo by authors)

Five years after the event, the Czech Hydrometeorological Institute recalculated the design flood discharges for the affected dams, increasing them almost two times. Appurtenant works for all the ponds in the basin were adapted to the new parameters. The use of fixed rather than gated spillways became a priority, as there was no need to manipulate them during a flood (the Pustý, Velký Bělčický, Luh, etc.).

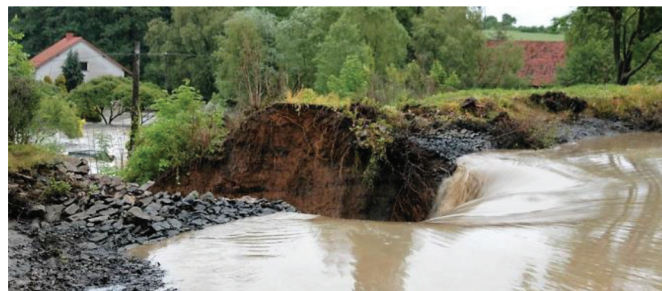
Fig. 5 The breach in the Mlékovice Dam during the 2013 flood (Švarc, 2014)

During the flash flood in June 2013, the peak inflow to the Mlékovice Pond was recorded on 2 June 2013 in the morning. The hydrological flood wave in the basin was increased by clogging and the rupture of the culvert at the road crossing Miletínský Stream upstream of the dam (Fig. 4). The resultant flood wave with an estimated peak discharge of 50 m<sup>3</sup>/s significantly exceeded the capacity of the spillways, which caused overtopping of the dam crest. In a short time, erosion initiated the breach (Fig. 5).

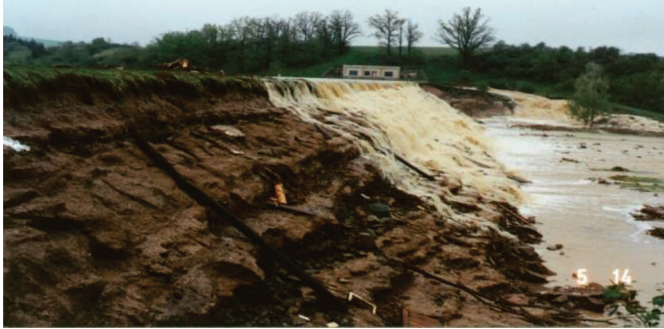
Fig. 6 Overtopping of the Pocheň Dam during the flood in 1996 (VD-TBD, 2021)

The main cause of the overtopping and damage to the Pocheň Dam was the extreme flood situation, which occurred relative to the extraordinary rainfall with a return period of higher than 100 years. A retrospective analysis of the spillway hydraulics confirmed that the spillway had insufficient capacity to transfer a flood with the newly declared return period of 20 years. Another problem was the insufficient freeboard combined with local subsidence of the dam crest (VD-TBD, 2021).

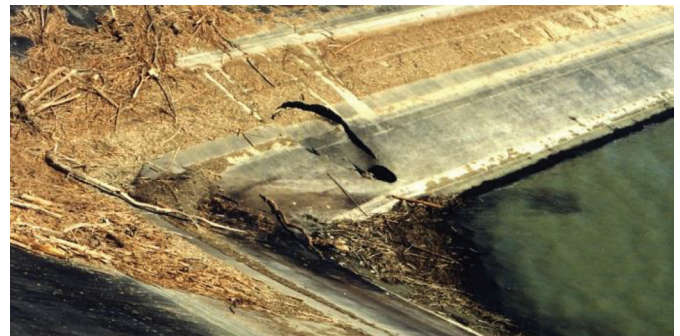
Fig. 8 Failure of the bituminous concrete facing of the Morávka Dam in 1996 (VD-TBD, 2021)

During the decades the asphalt face degraded, namely, due to the seepage instability of the fill material below the lining. The surface of the slope became uneven with numerous depressions indicating missing material and the development of local caverns below the face. The internal process was accelerated by the seepage coming from the left abutment combined with local leaks through the sealing. The asphaltic lining below the permanent storage level experienced serious damage after a flood in 1996 when the sealing cracked counting the area approximately 10 m<sup>2</sup> (Figs. 7, 8). The material of the dam body under the sealing was being transferred to the foundation due to leaks in the sealing (Březina et al., 1998; Kratochvíl and Glac, 2006). The dam was completely reconstructed in the years 1997 – 2000, including an upgrade of the existing bottom outlets, the installation of a new bypass tunnel with additional bottom outlets, the reconstruction of the sealing by milling the upper layers and replacing them with a Sibelon PVC geomembrane, and the drilling of a drainage tunnel at the left abutment.

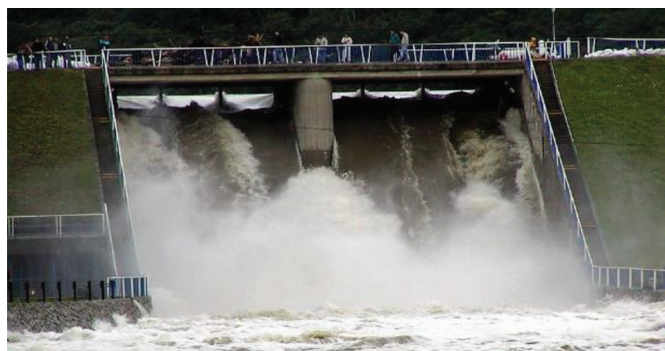
**Fig. 9** The original spillway almost choked up during the flood in 2002 (VD-TBD, 2021)

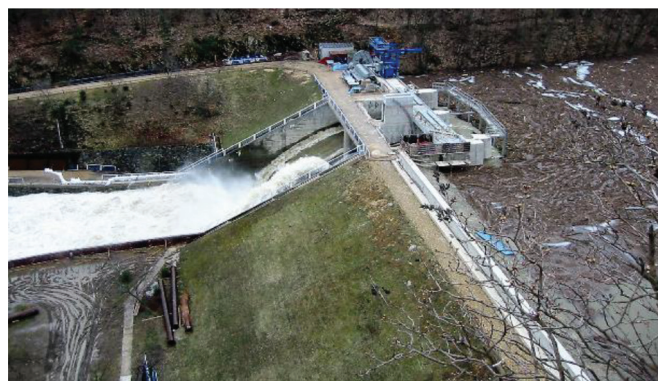
**Fig. 10** Reconstructed spillway with steel traps during the flood in 2006 (VD-TBD, 2021)

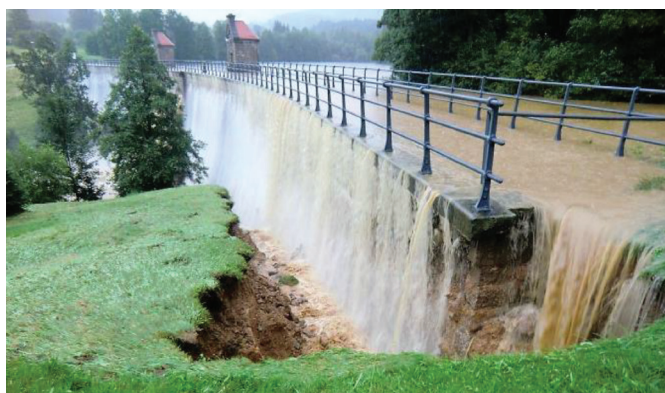
**Fig. 12** Overtopping of the Mlýnice Dam during the flood in 2010 (VD-TBD, 2021)

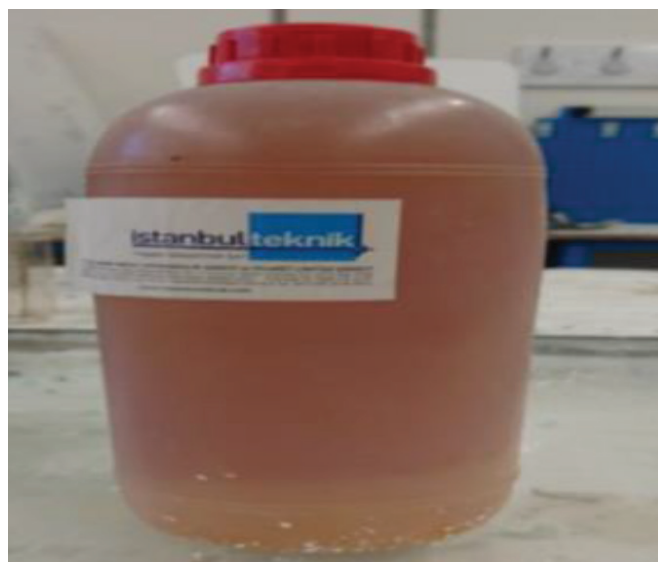
Fig. 1.1. A additive

According to the Turkish national standards, the recommended bitumen grades for the province where the study was conducted were chosen as 4.2% and 4.8% with a 50/70 penetration for the binder and surface courses. The additives used in this study were determined as “A”, which is an amidoamine derivative and polyamine used in the industry and with long-chain aliphatic hydrocarbon content “B”. These two additives are still used in the road industry and are well-known products. Also, three other additives (a) with a hydrocarbon resin and synthetic-based mineral content named “HYR-901”, (b) with atactic polypropylene and polyolefin content named “Lomot”, and (c) elastomer rubber SEBS compound content named “PDL6020” are newly produced and used for the first time (Tab. 1 and Fig. 1).

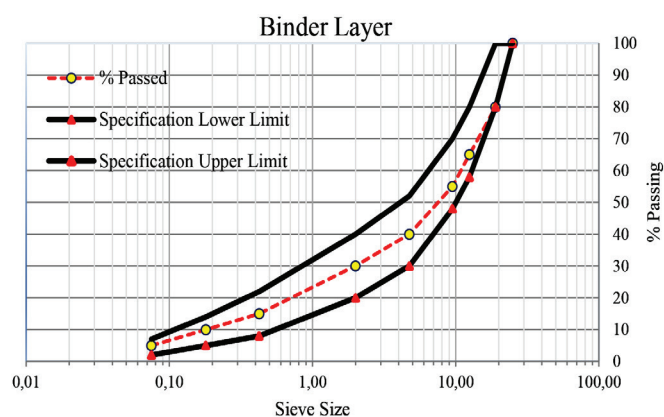
Fig. 2 Grading curve of used asphalt concrete for pavement binder layer

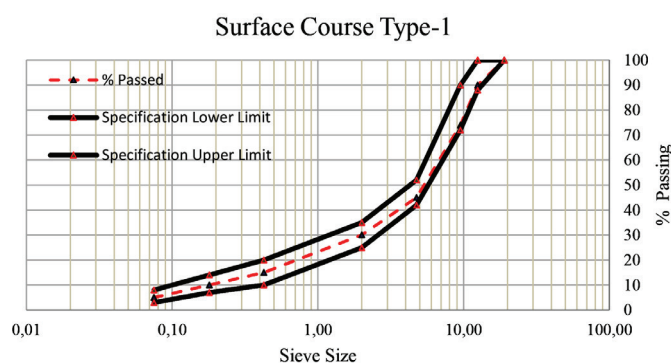
**Fig. 3** Grading curve of used asphalt concrete for pavement surface layer

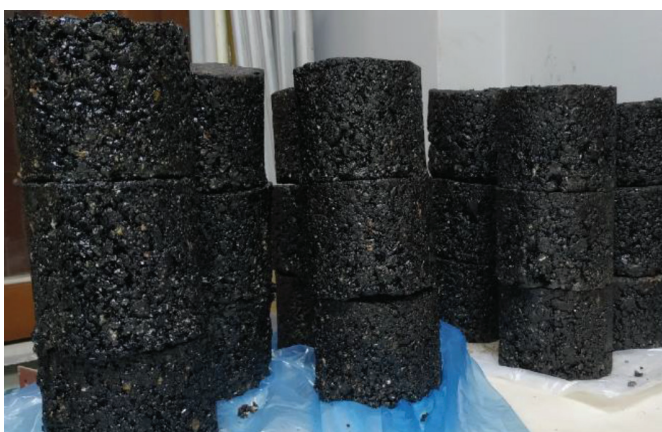
Fig. 9.a Marshall Specimen

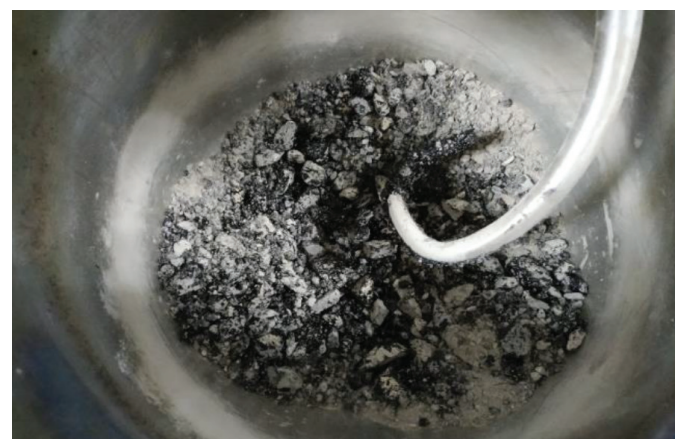
Fig. 9.b Not mixed specimen without additive

best performance. Nevertheless, they achieved the specified values in the additive samples. It is predicted that the samples with additives can be evaluated and used due to the low-temperature factor. Additive A gave the best results in terms of the stability value, and the B additive gave the best results in the flow values. The samples subjected to the experiment are shown in Fig. 9.a., and the appearance of the sample in the mixer that was not successfully mixed at 135°C is shown in Fig. 9.b.

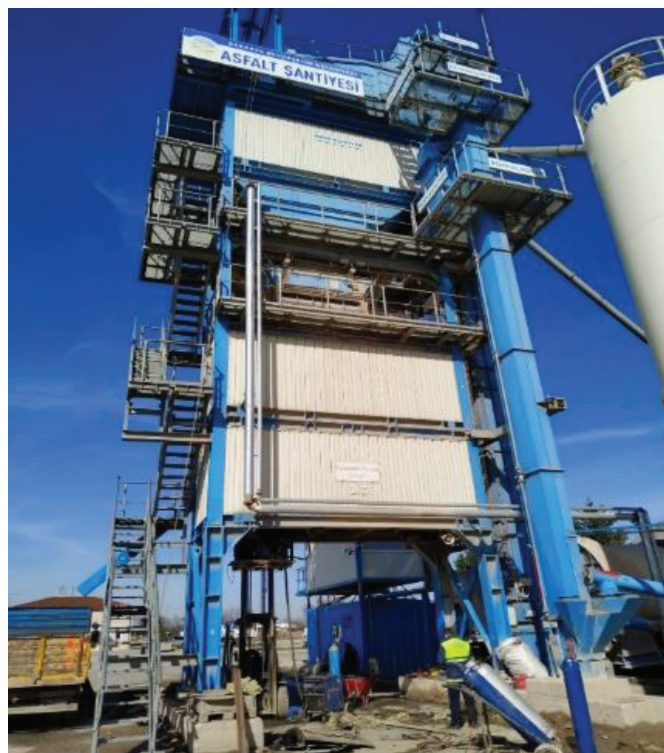
**Fig. 10** ECO 4000 Benninghoven module plant

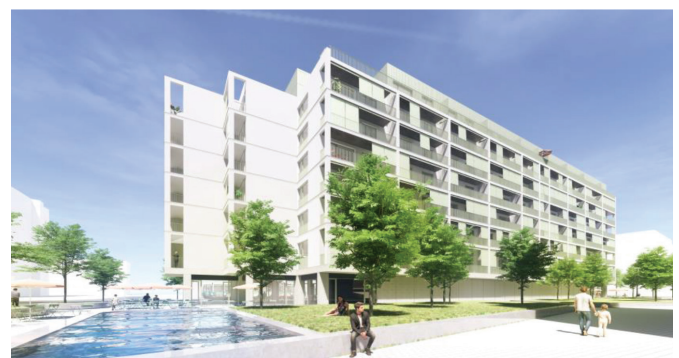
The subject of the case study is a multifunctional residential building (Fig. 6) in Slovakia with 98 residential units and an estimated population of 211; it consists of parking spaces, storage spaces, and the technical facilities of the building on an underground floor. The entrance and the non-residential, commercial, and administrative spaces are located above-ground on the first and second floors. The apartment units are located on the third to eighth floors, with smaller apartments

**Fig. 6** View of the multifunctional apartment building from the inner block (Penta Real Estate, Ltd.)

facing one side of the building and larger apartments facing the inner block. The building is built to a standard that meets the requirements for class A0 energy certification.
